4.4 Siding and Trim Design Guidelines

4.4.1 INTRODUCTION

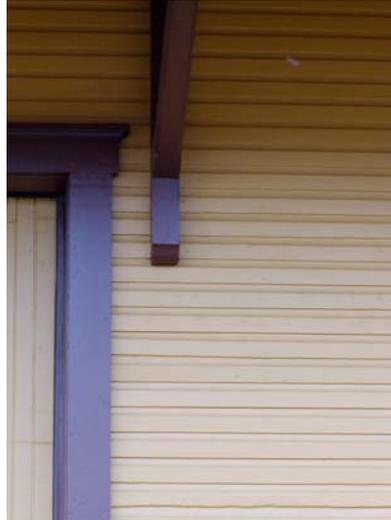
TYPICAL ‘LAPPED’ SIDING

Wood siding typically used in Grapevine houses are horizontal siding with either a top front rabbet and a bottom rear rabbet that lap the board below or tongue-and-groove edges; this siding is installed directly against the wall (exterior studs) of the house, and is commonly referred to as ‘drop’ or novelty siding.

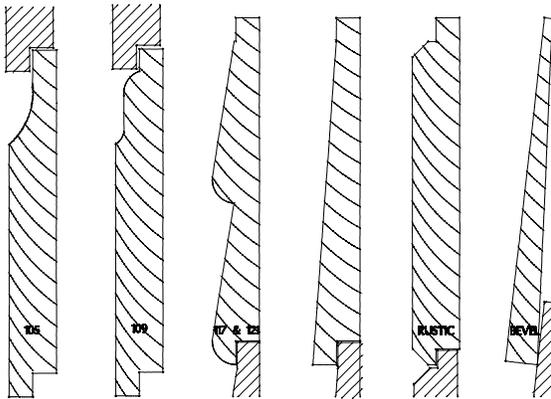
TYPICAL WOOD HORIZONTAL SIDING PROFILES

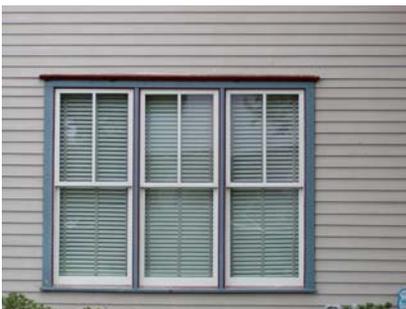
TYPICAL NOVELTY SIDING

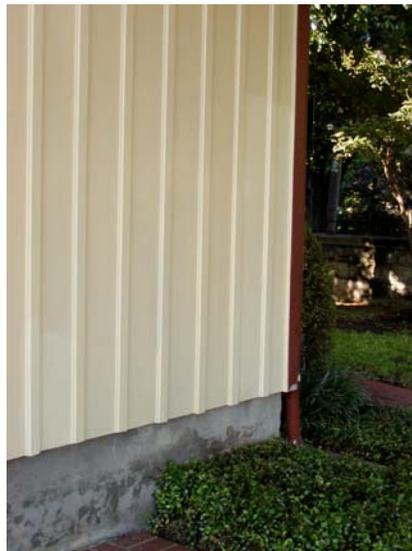
BOARD AND BATTEN SIDING

Board and batten siding is also a common siding type and is used at the side and rear of commercial properties, some houses and particularly at accessory buildings. Wide vertical boards are applied directly to the structure, and are then covered at the joints with narrow boards (battens). A ‘reverse’ board and batten siding has the smaller boards (battens) applied directly to the structure with the larger boards at the top.

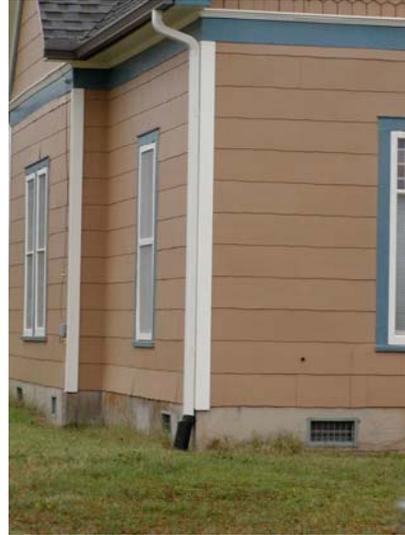
**ASBESTOS SIDING which
RETAINS THE WINDOW TRIM,
CORNER BOARDS and FASCIA**

Typically, these shingles were nailed directly to the wood siding, and the corner boards, window and door trim and other trim elements were often left in place. However, roof brackets, porch brackets and trim that was considered to be ornamentation was removed to accommodate these new siding materials.

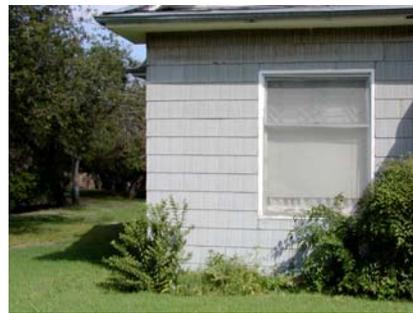
**ASBESTOS SIDING with
HISTORIC TRIM REMOVED**

These siding materials bear little resemblance to historic siding materials. While the original massing and style of the building was retained after replacement of the siding, much of the historic character was lost due to both the change in texture of the siding, and the loss of trim and ornamentation on the building.

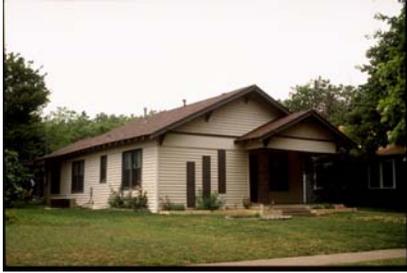
METAL SIDING with CHANGES AT WINDOWS and LOSS of MAJORITY OF TRIM

Modern synthetic materials such as metal (typically aluminum) and vinyl siding, are applied in a manner similar to the older shingles – directly on top of the historic siding, although rigid insulation may now be installed. With these newer types of siding, the existing window, door and other trim elements are typically removed and discarded as these synthetic siding systems provide new, low-profile trim at doors, windows, corners, etc.

Synthetic siding materials adversely affect the appearance of a historic residence and typically result in the loss of historic elements that are critical to the character of the building: door and window trim, roof brackets and other decorative trim, texture of the siding. Loss of this historic character at one building also alters the historic visual relationship between the buildings in a district.

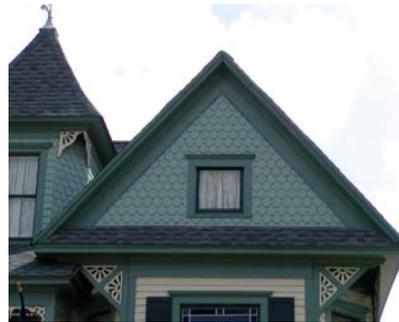
TRIM AT A QUEEN ANNE HOUSE: GABLE TRIM, WINDOW TRIM, FINIAL AT ROOF, TEXTURED SHINGLES AT GABLE and DECORATIVE CORNER BRACKETS.

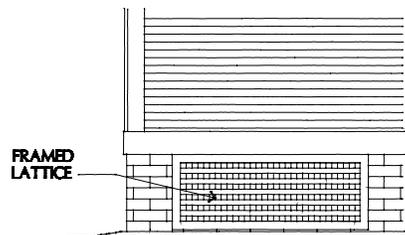
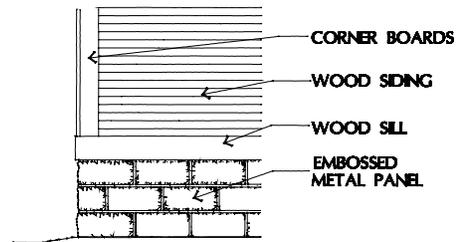
RESIDENTIAL BUILDING SKIRTING

In addition, new skirting at residential buildings shall be appropriate to the building. Wood siding as a continuation of the siding on the walls, lattice that is ‘framed’ or pressed metal are examples of appropriate skirting materials.

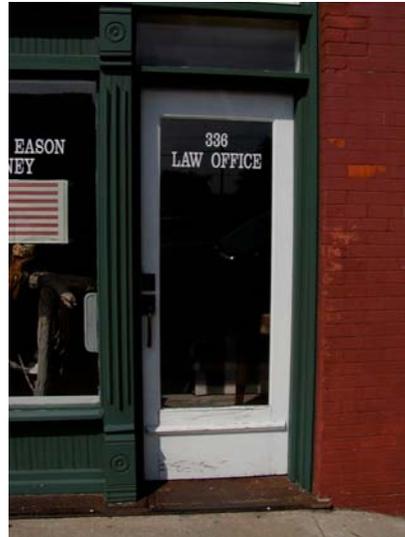
WOOD TRIM at DOORS, WINDOWS and BASE OF SIDING at COMMERCIAL STOREFRONT REINFORCES TRIM DESIGN
